Rota West Harbor Master Plan (CPA-RS-001-15)

Commonwealth Ports Authority Commonwealth of the Northern Mariana Islands ATOSSCOM 2018

August 1, 2018

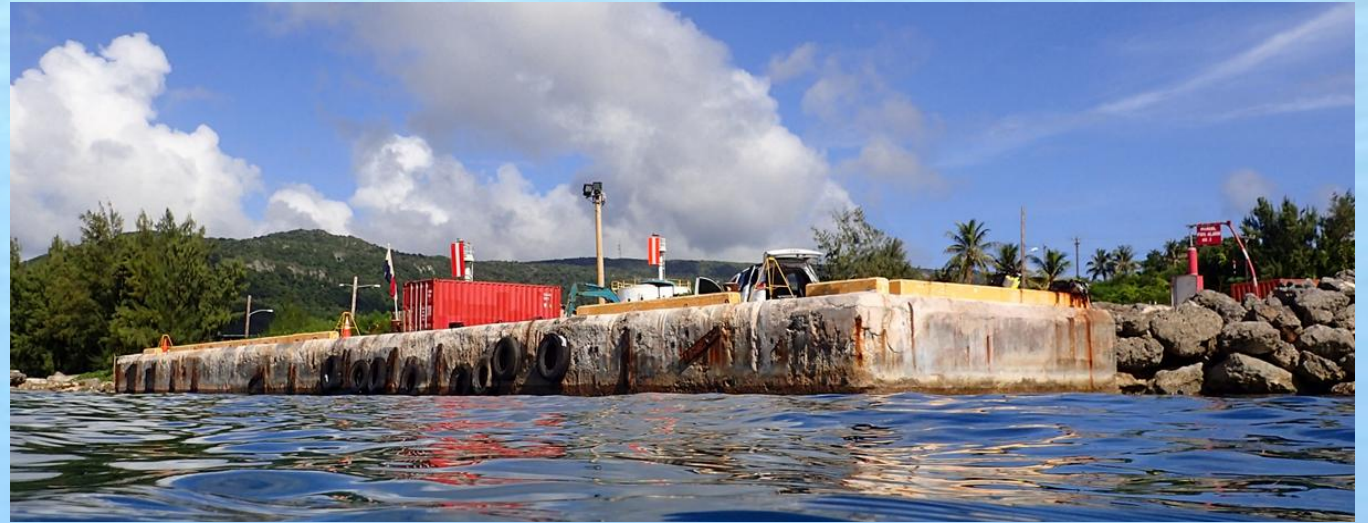
► **Berth 1:** Quay wall corrosion, loss of backfill, missing fenders, damaged cap beam, debris and shoaling

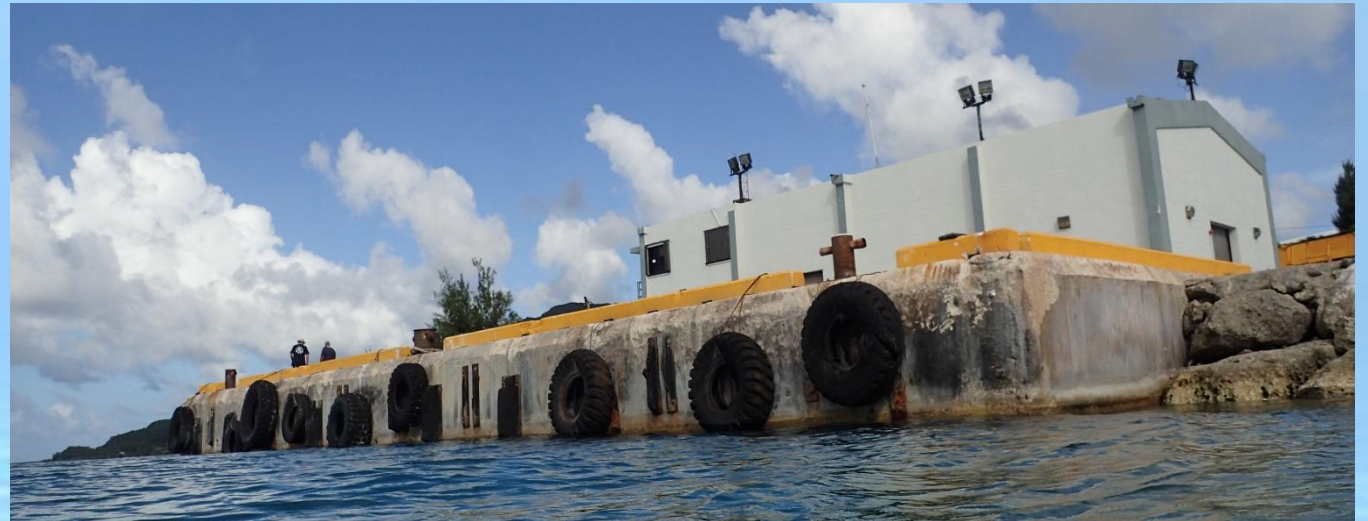
► **Berth 2:** Quay wall corrosion, loss of backfill missing fenders

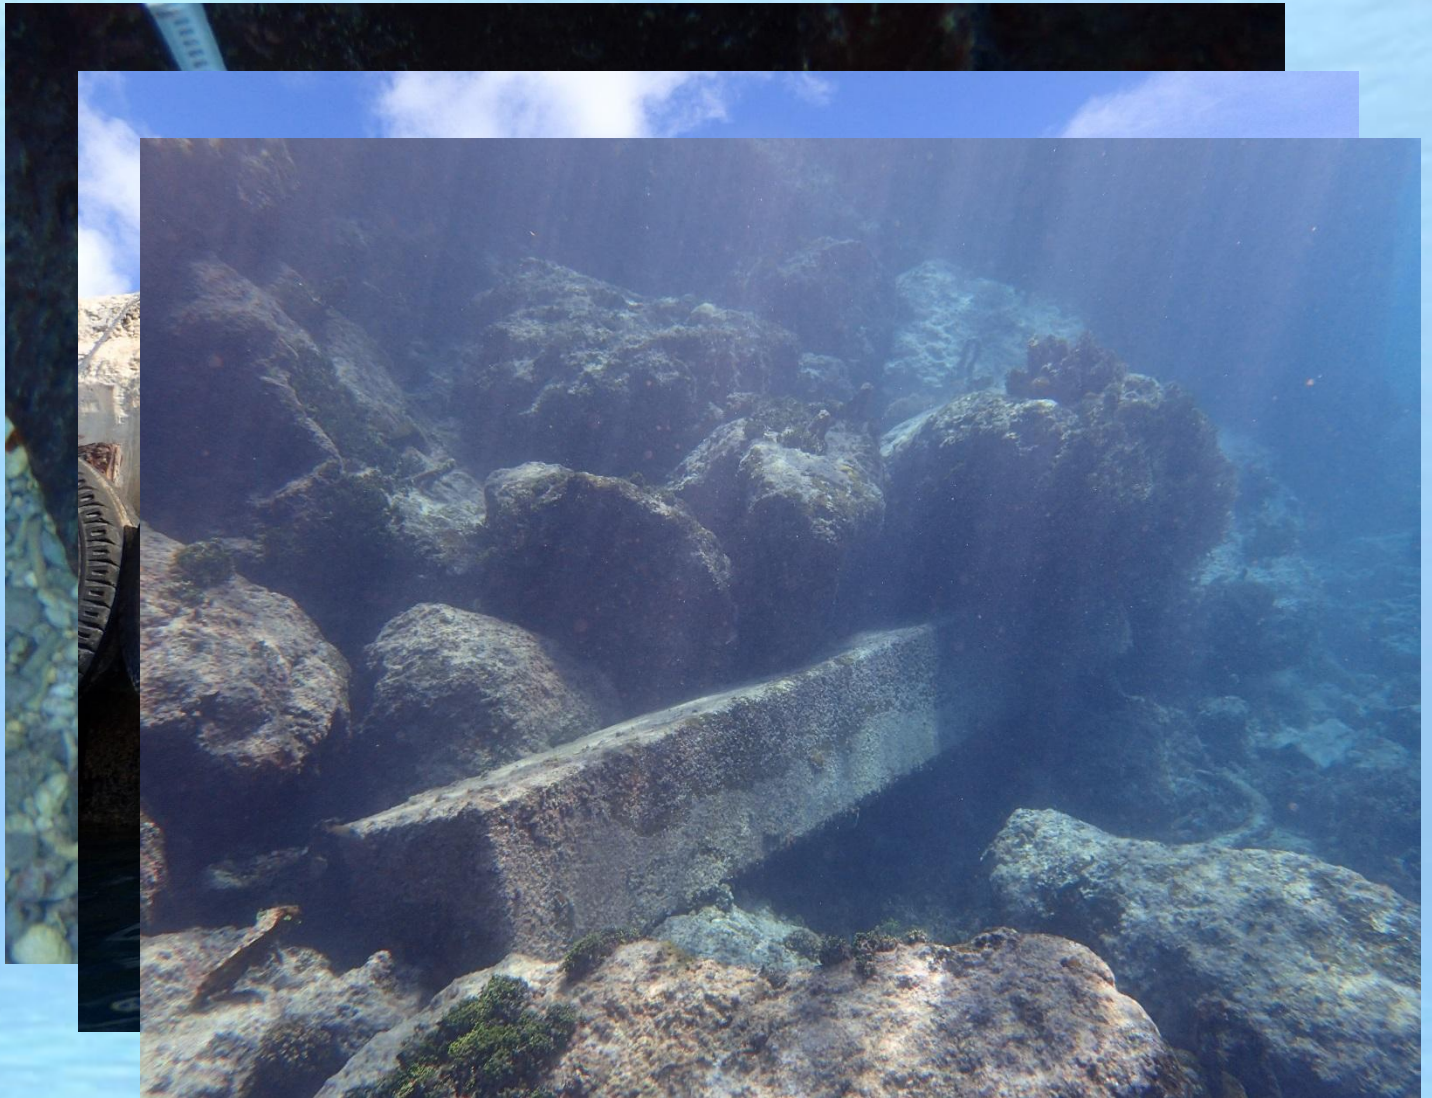
Rota West Harbor Berth Condition

- Sheet pile corrosion & loss of backfill
- Missing fenders & eroded cap-beam
- Debris and shoaling

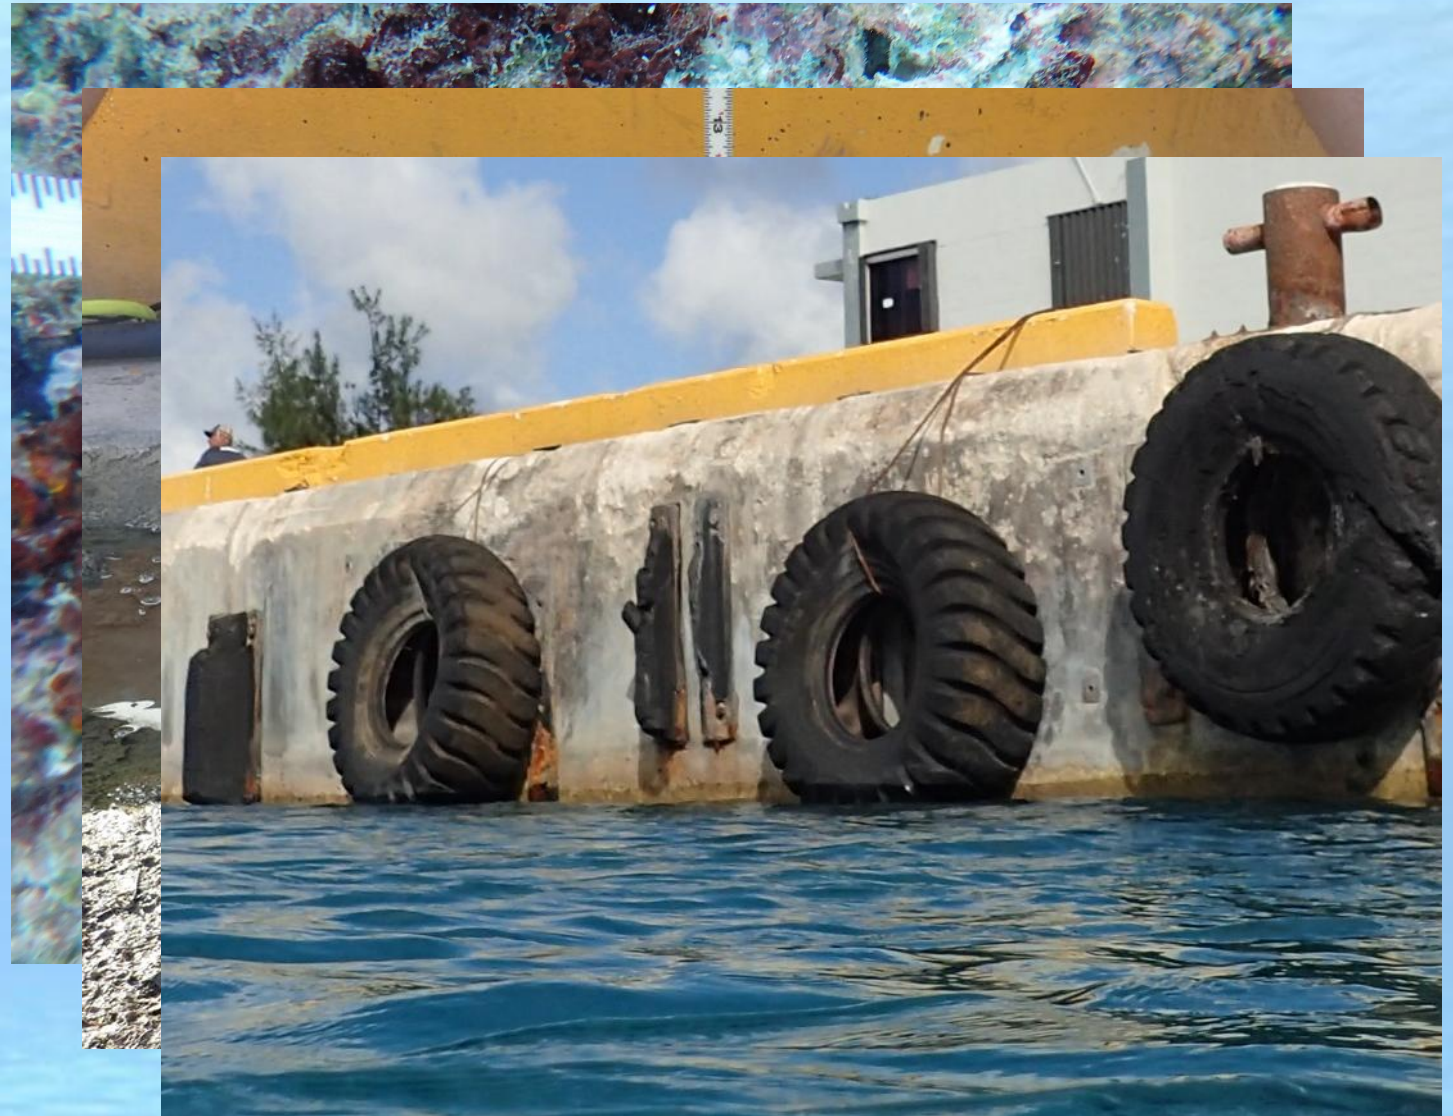
Rota West Harbor Berth 1 Condition

- Quay wall corrosion
- Loss of backfill
- Lack of Fendering

- Berth 1 upgrades

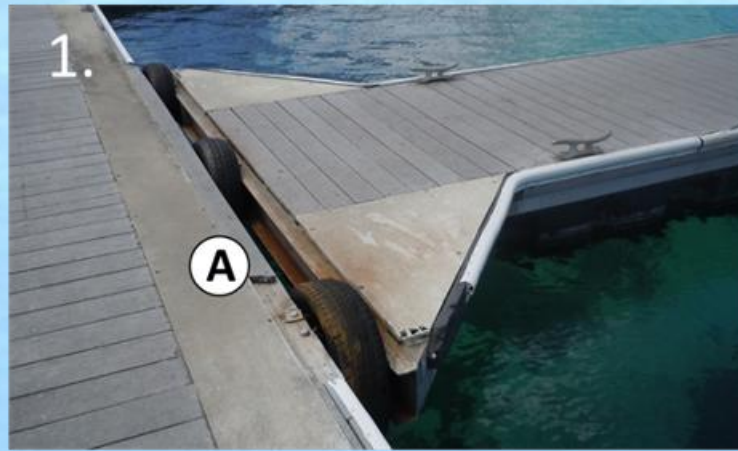
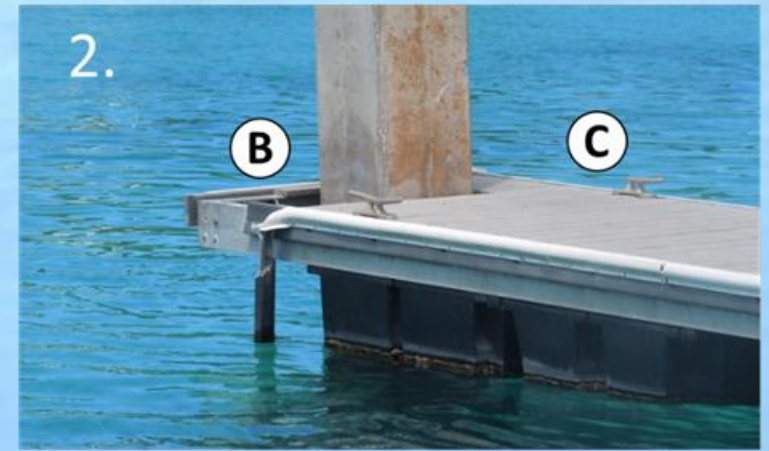
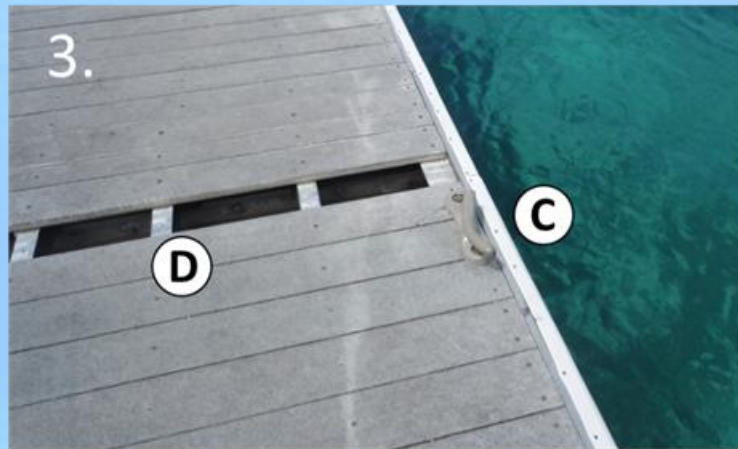
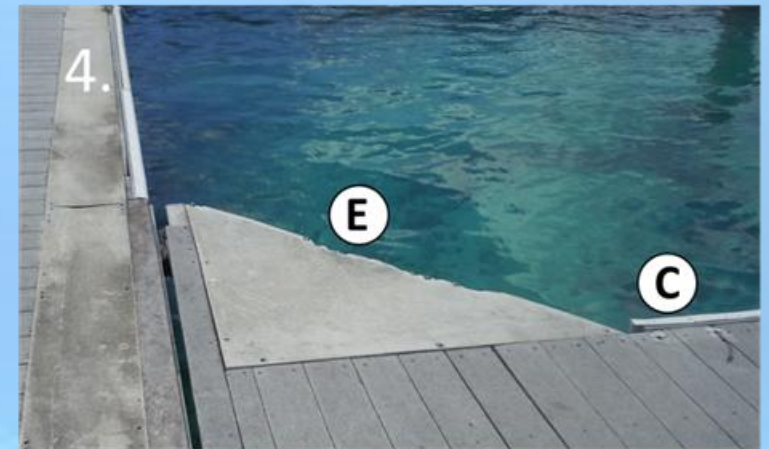
Rota West Harbor Public Facilities Condition

- A. Separated Finger-Float Connection
- B. Broken Pile Guide
- C. Damaged Fenders
- D. Missing Deck Boards
- E. Damaged Wing Gusset
